RICS Home Surveys  
Building Survey

XXXXXXXXXXXXX, XXXXXXXXX,  
XXXXXXXXXXXXX, XXXXXXXXXXXXXXX

1st March 2020

SAMPLE REPORT

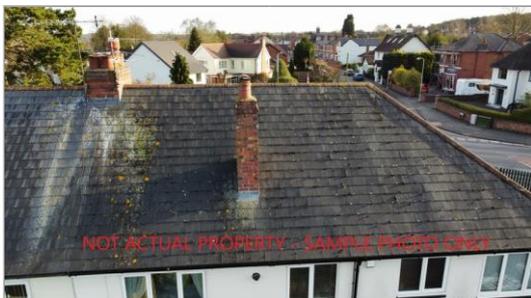
There are a number of missing tiles to the rear left roof slope. There are also a number of slipped, chipped and cracked tiles visible on all roof pitches. To ensure water tightness the damaged and missing tiles should be replaced soon.

Photo - 4 Roof rear

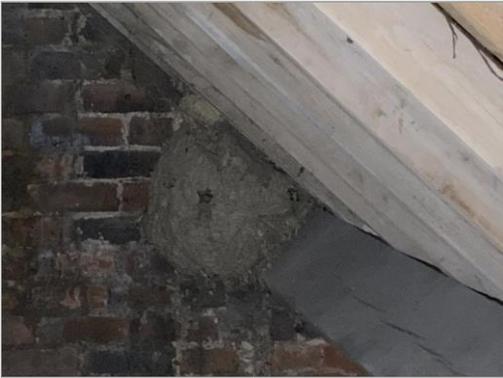
Photo - 22 Large wasps nests rear roof

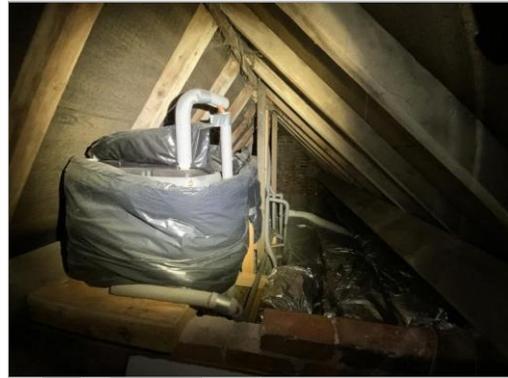
Photo - 23 Water tanks rear roof

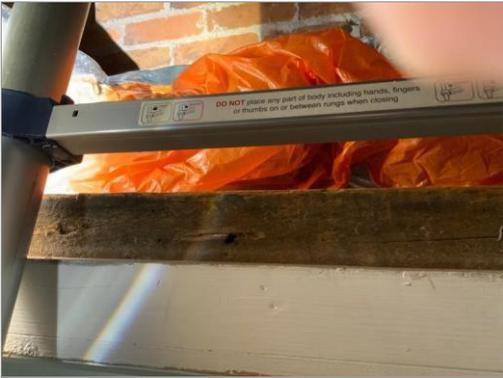
Photo - 24 Wood boring beetle in loft hatch surround rear roof

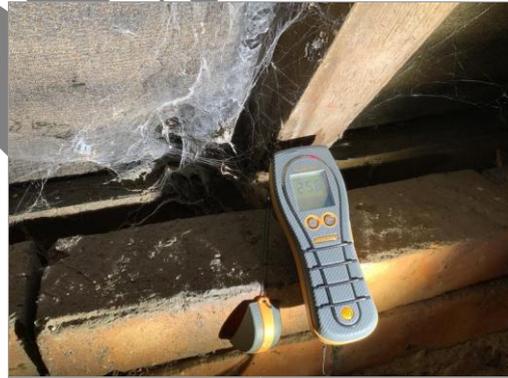
Dampness was noted in the ends of the rafters to the front elevation (see Section F1). This is often caused when the bitumen roofing felt perishes at the edge of the roofing covering where this is dressed to the gutter. This defect is common with felt of this age. The lower row of felt should be replaced which should be dressed into the gutters. Alternatively, plastic eaves protectors could be installed to the wall plate to ensure that rainwater discharges to the gutter effectively. This work should be carried out as

Photo - 25 Damp to ends of rafters

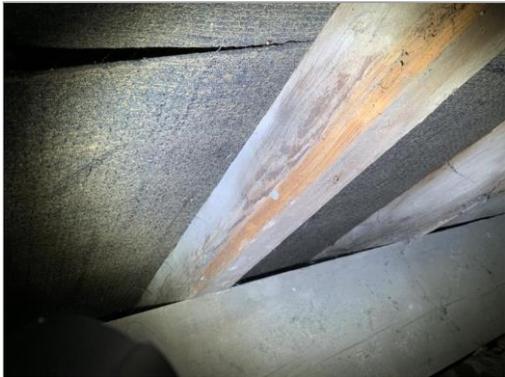
Photo - 26 Wood boring insect attack front roof space

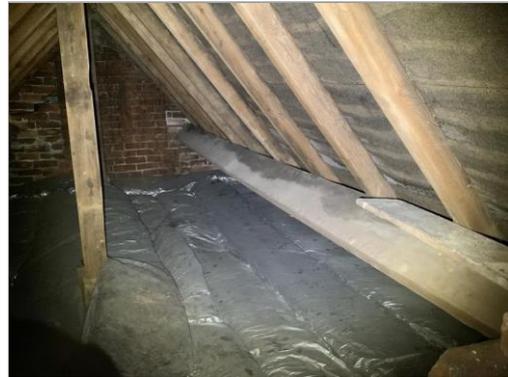
Photo - 27 Damp staining to Purlin front roof space

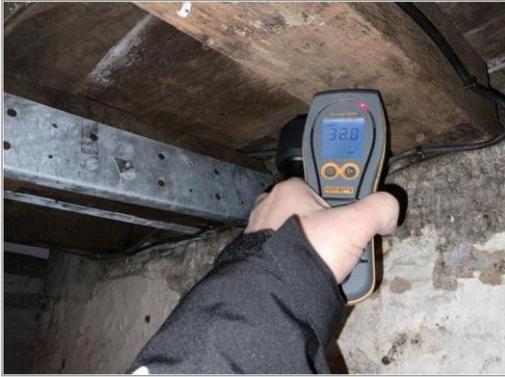
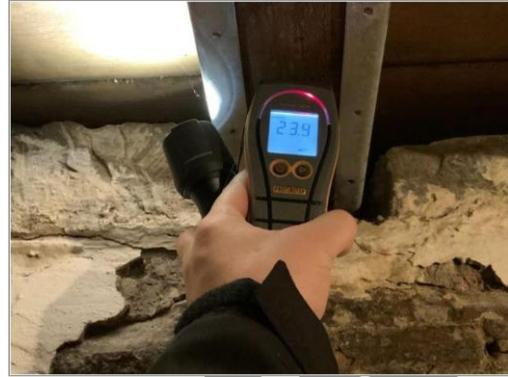
Photo - 32 High damp readings to timbers

Photo - 33 High damp readings to timbers

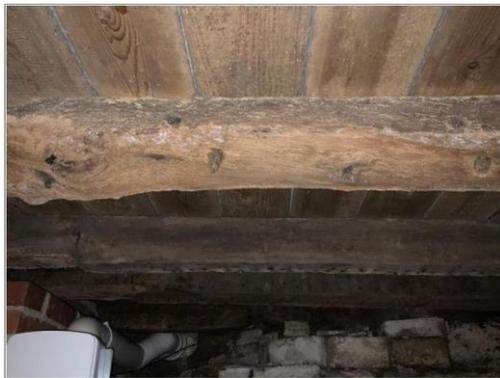
Photo - 34 Decay to timbers

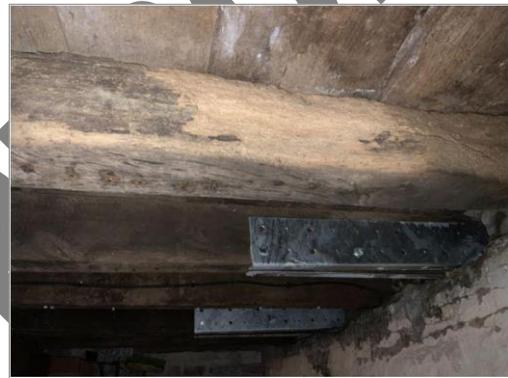
Photo - 35 Wood boring insect attack

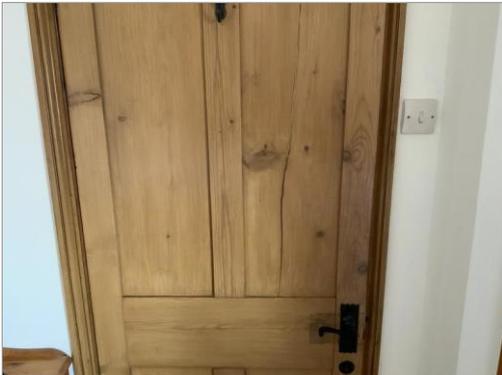
Photo - 37 Splits in door panels

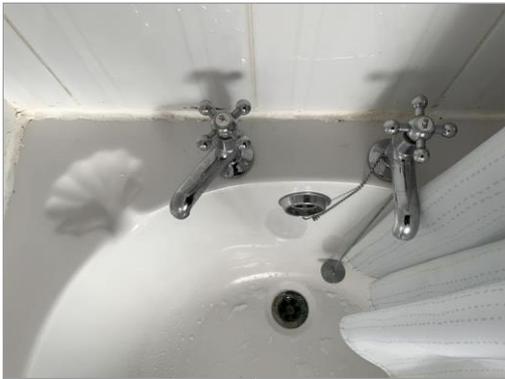
Photo - 38 Hot tap loose

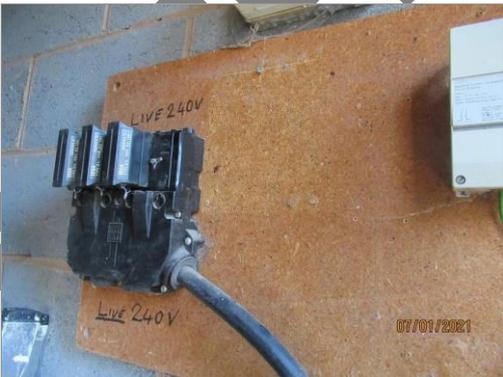
Photo - 43 Three phase supply in garage

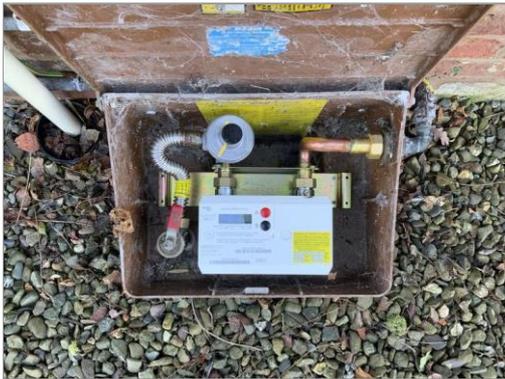
Photo - 45

Condition rating 3. FURTHER INVESTIGATION REQUIRED.

You should ask an appropriately qualified person to inspect the gas installation prior to exchange of contracts.

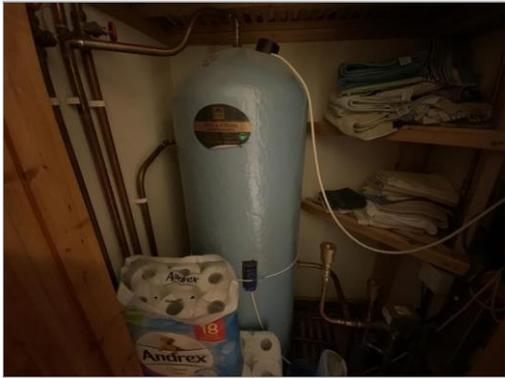
Photo - 47 Insulated copper cylinder.

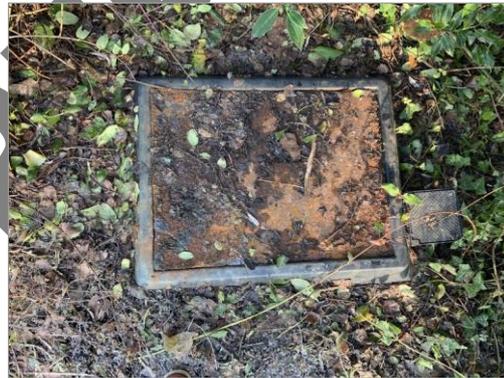
Photo - 49 Cover corroded
