RICS Home Surveys  
Building Survey

XXXXXXXXXXXXX, XXXXXXXXX,  
XXXXXXXXXXXXX, XXXXXXXXXXXXXXX

1st March 2020

SAMPLE REPORT

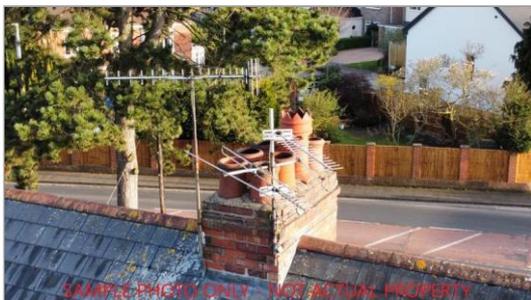
Photo - 2 Sample photos

The stacks and associated elements were in satisfactory condition. The vendor informs us that the stacks were overhauled in 2020 which included re-pointing and repairs to flashings.

Condition rating 1 - No repairs currently required.

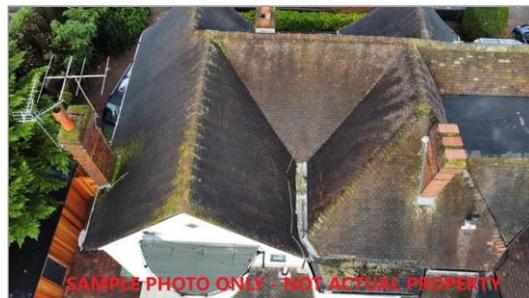
Photo - 5 Sample photos

- Mortar has eroded to sections of the verges to both sides of the property. This could allow rainwater to penetrate the ends of the timber battens and the roof space.
- Dampness was noted in the ends of the rafters this normally occurs due to degraded under felt at the edges of the roof (the eaves).
- There are a number of missing tiles to the rear right left roof slope. - There are a number of chipped, slipped and cracked tiles.

Condition rating 2 - Repairs required.

There are a number of missing tiles to the rear left roof slope. There are also a number of slipped, chipped and cracked tiles visible on all roof pitches. To ensure water tightness the damaged and missing tiles should be replaced soon.

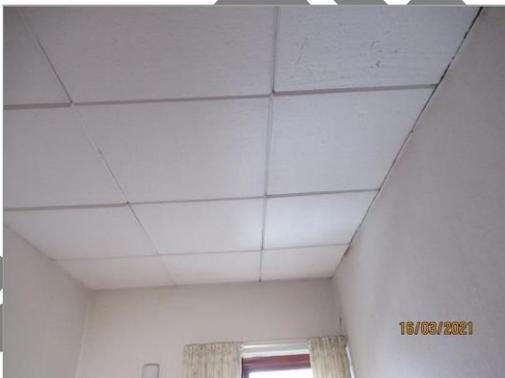
Photo - 28 Sample photos of defects

The ceilings are generally secure and all surfaces are presented in fair decorative order. There was some visible unevenness and cracking to some of the ceilings, however, this is consistent with the age of the property. Such cracks can be unsightly but are rarely of structural significance. Condition rating 1. No repair is currently needed. The property must be maintained in the normal way.
